Engine Exhaust Coating Comparison

Joe DeMonte

Senior Thermography Course Instructor

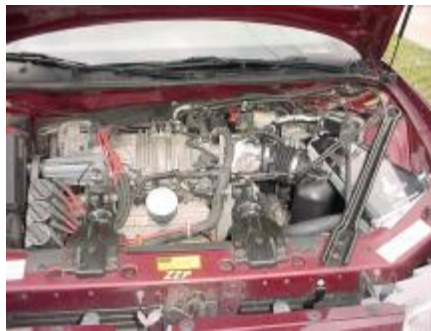
Figure 1: The Engine

Modern engines with fuel injection and electronic computer controls have become increasingly complex and more efficient with each engineering advancement. Smaller displacement engines can now offer excellent gas mileage along with unheard of power and performance. In this test, we decided to use the car that we currently race at IHRA and NHRA drag strips across the east. Our test car is a 98 Buick Regal GS with a supercharged 3.8 liter fuel injected front wheel drive engine. The engine came stock with heat reducing radiant barriers on the exhaust components. This was a sign to me that heat reduction is carefully considered by the manufacturer during design on new vehicles.

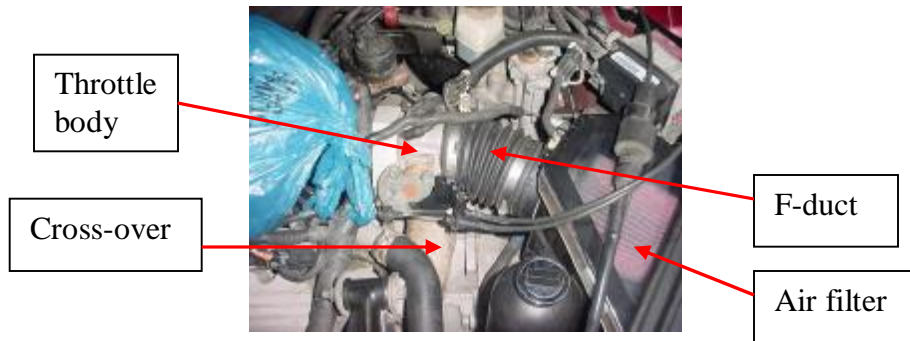
Fig 7: Throttle body and F-duct in the visible spectrum

The first cross-over used was the silver ceramic coated. Our data was taken with a FLIR S60 longwave infrared camera. This camera detects infrared light and has the radiometric ability to convert the intensity of the infrared into a temperature measurement. We used the FLIR S60 to show us the thermal patterns of a large area under the car's hood, and make non-contact temperature measurements for comparison between the different exhaust pipes. Not all objects are efficient at emitting radiant energy, so we took care in the materials that we chose to measure. We will be looking at the throttle body and the F-duct due to their proximity to the cross-over pipe.
